# Project 1 Knox City Council & Knox Transfer Station Pty Ltd

## Brief description of applicant, site & operation

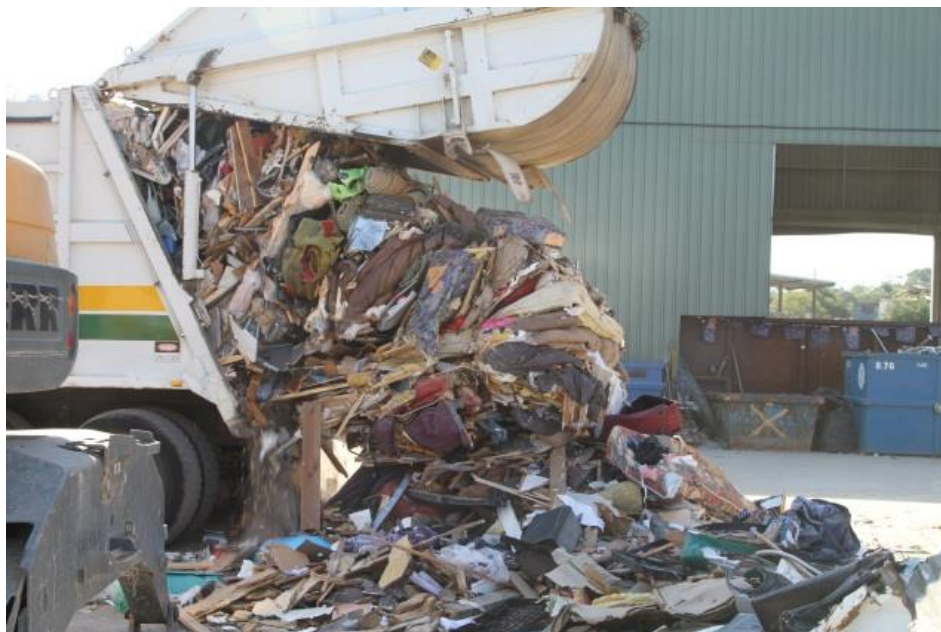
Compacted mattresses in a load of hard-waste

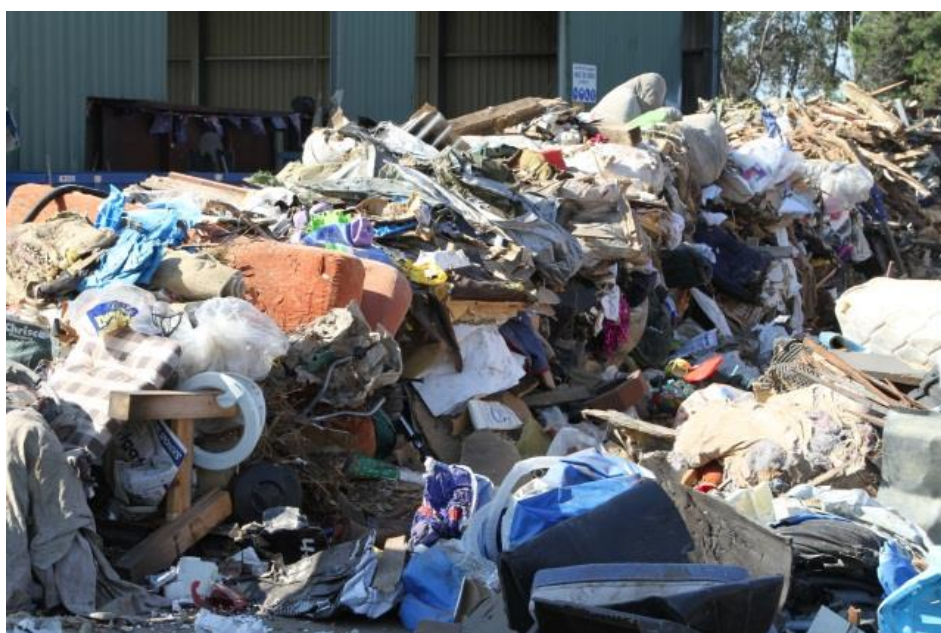
Compacted mattresses & hard-waste discharged onto receiving pad

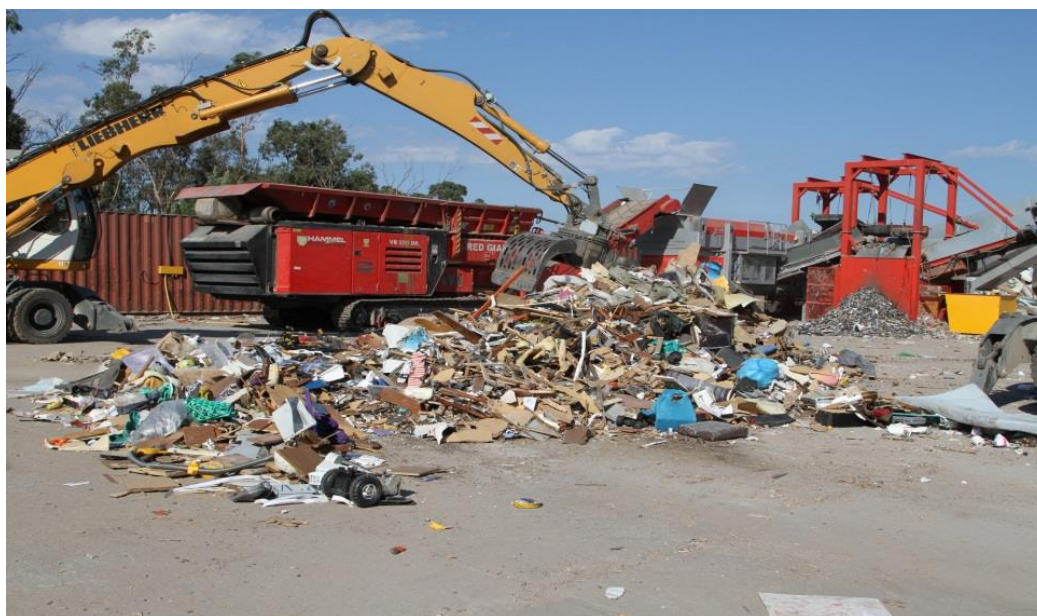
Excavator-grab loading mixed hard-waste into Hammel VB 750D Shredder.

The shredder would be used to process spring mattresses and hard waste. This slow speed shredder is designed to process difficult materials and has more than double the capacity and power of the VB 450 machine used previously by Dreamsafe.
